# PROJECT REPORT

## Fuel Management System

CHH Pine Panels, Oberon, NSW, Australia  
2002

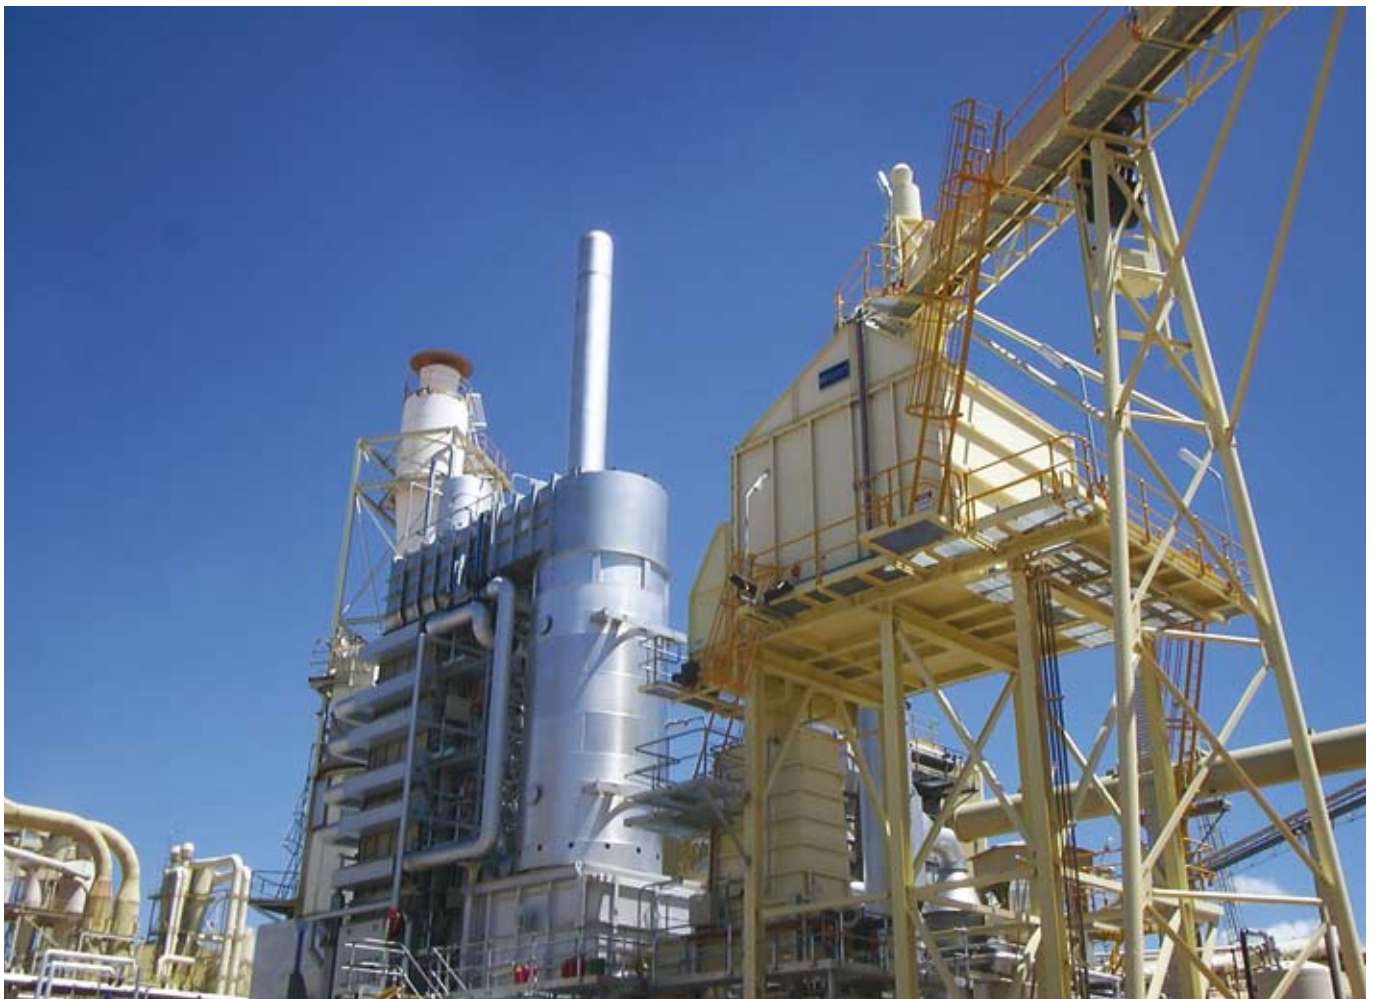
Elevated Fuel Metering System

The equipment installed by Brightwater included coarse fuel screening, dust screening, a fully enclosed dry fuel push floor bunker and a 90 cubic metre capacity

elevated mixed fuel surge bunker situated close to the boiler plant.

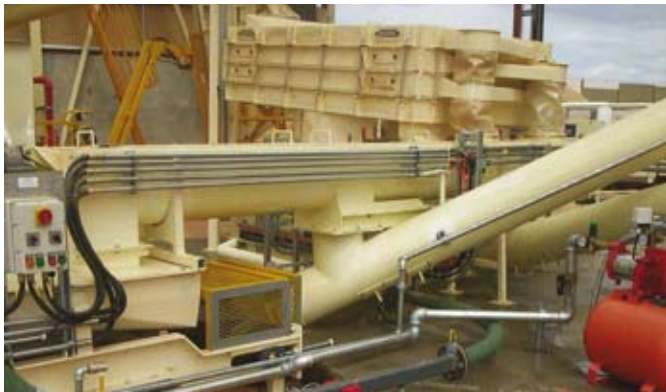
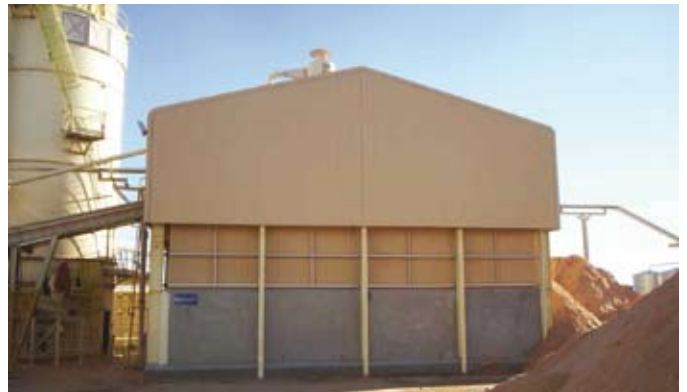
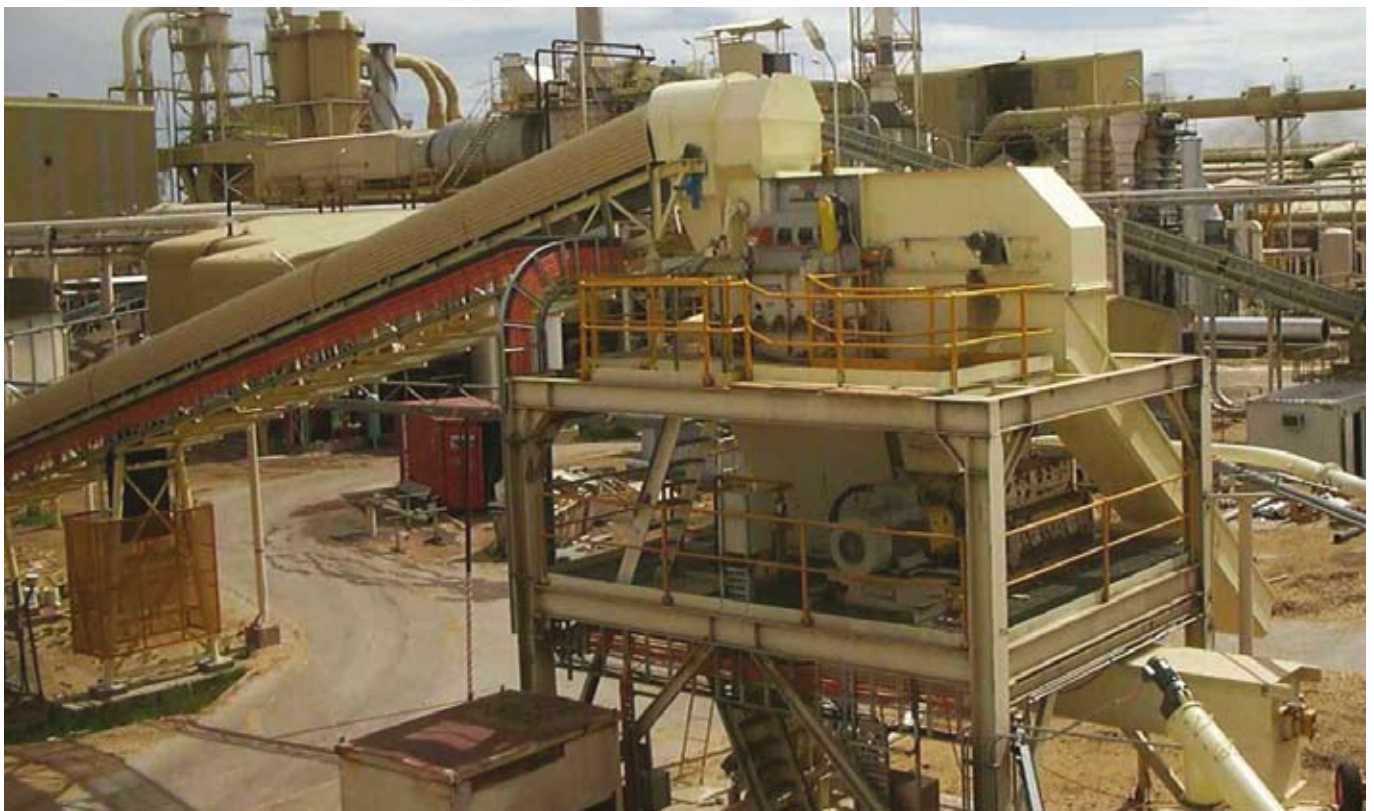
In addition, conveyor systems were installed between the major items of equipment. Work on site included considerable reconfiguration of the existing fuel management system to align it with the new equipment.
